NRCS-NM, C factors for RUSLE 1.06c, September, 2003

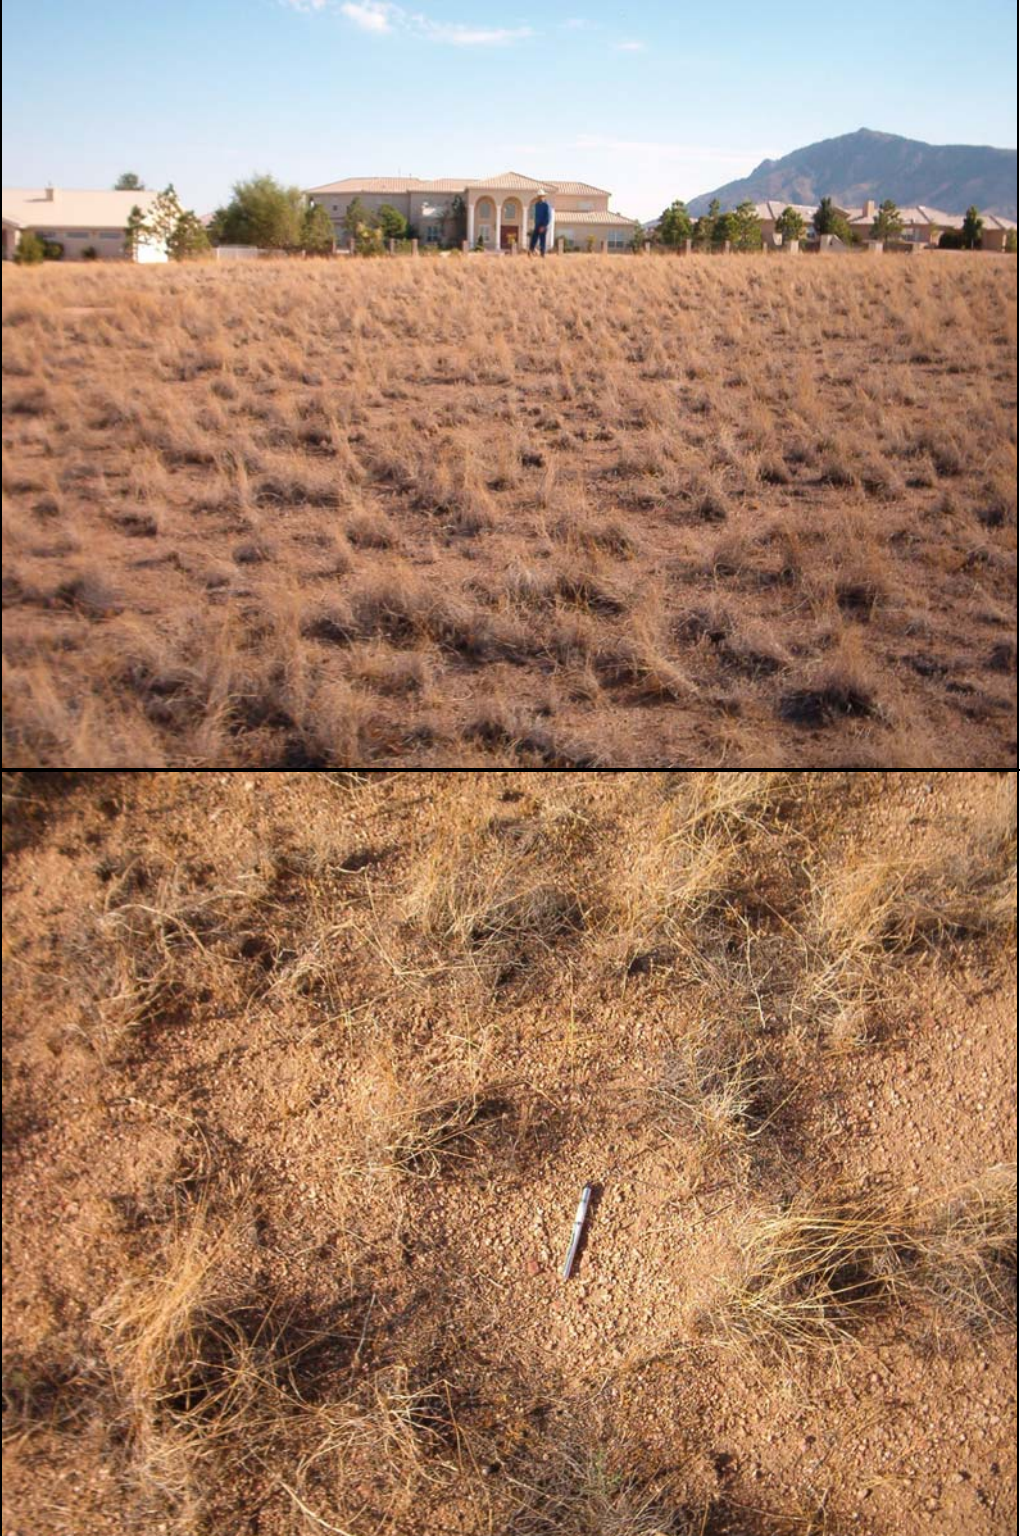
Site Description	C Factor	Picture
<p>Black Grama, 30% Cover, (150 lbs/ac Biomass), Fall Ht 0.2 ft, No disturbance, b-value =.05 File Name = BlkGram</p>	<p>0.059</p>

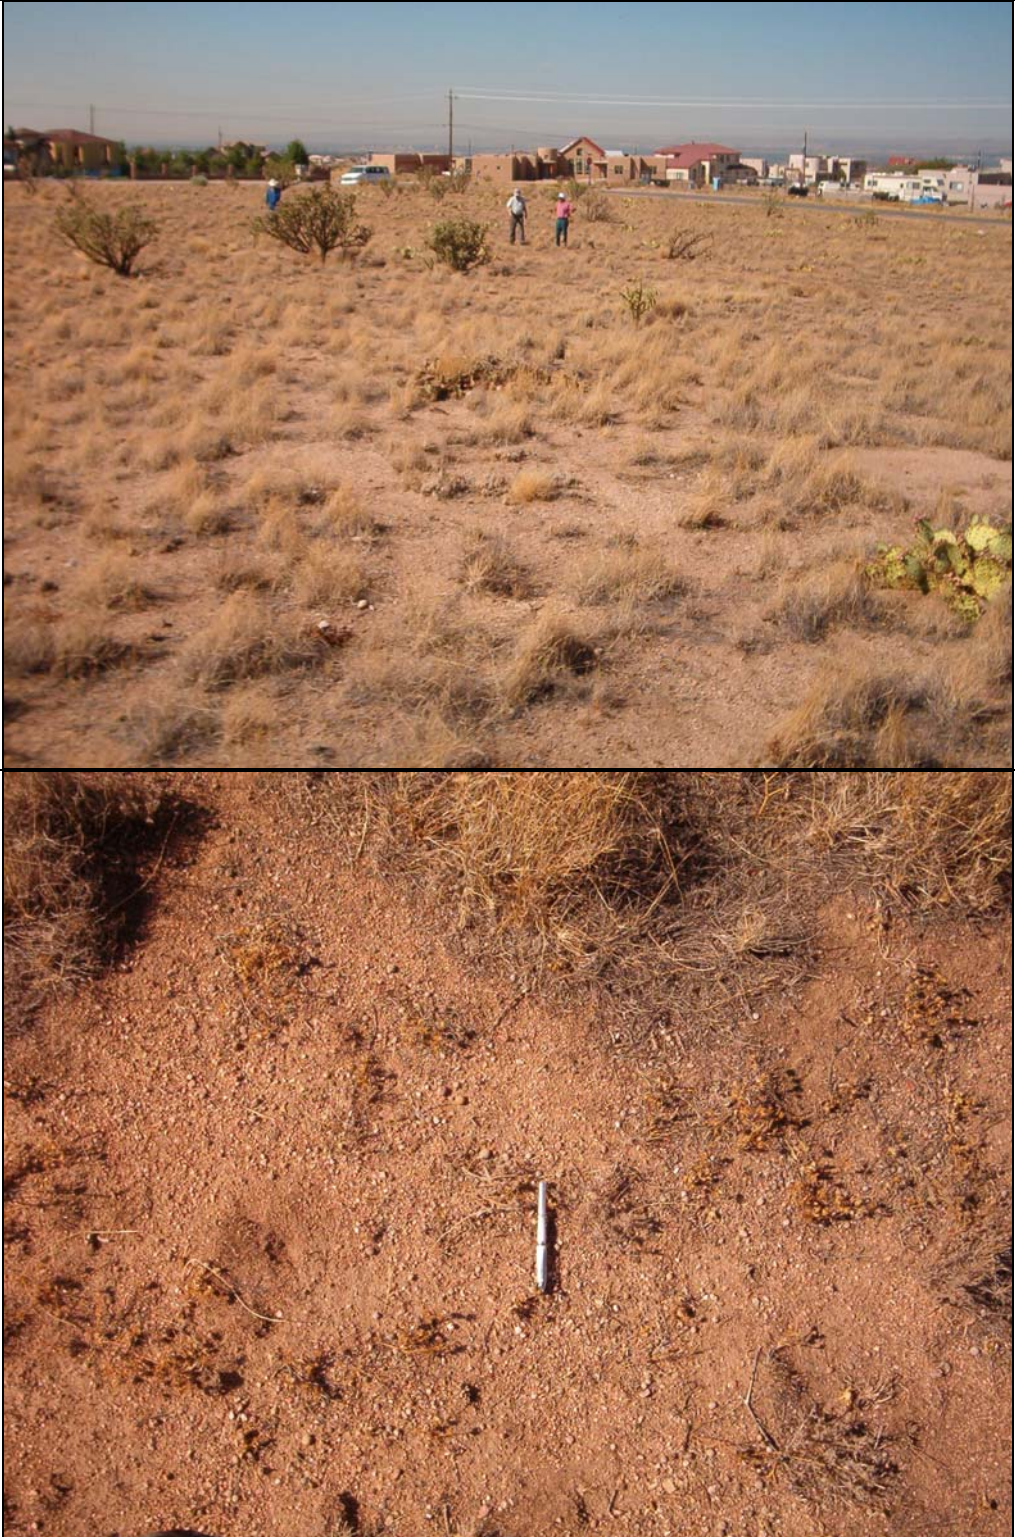
Site Description	C Factor	Picture
<p>Black Grama/Cholla, 10% Cover, 50 lbs/ac Biomass, Fall Ht 0.2 ft, RR=0.03, b-value=0.05 File Name= GramChol</p>	<p>0.08</p>

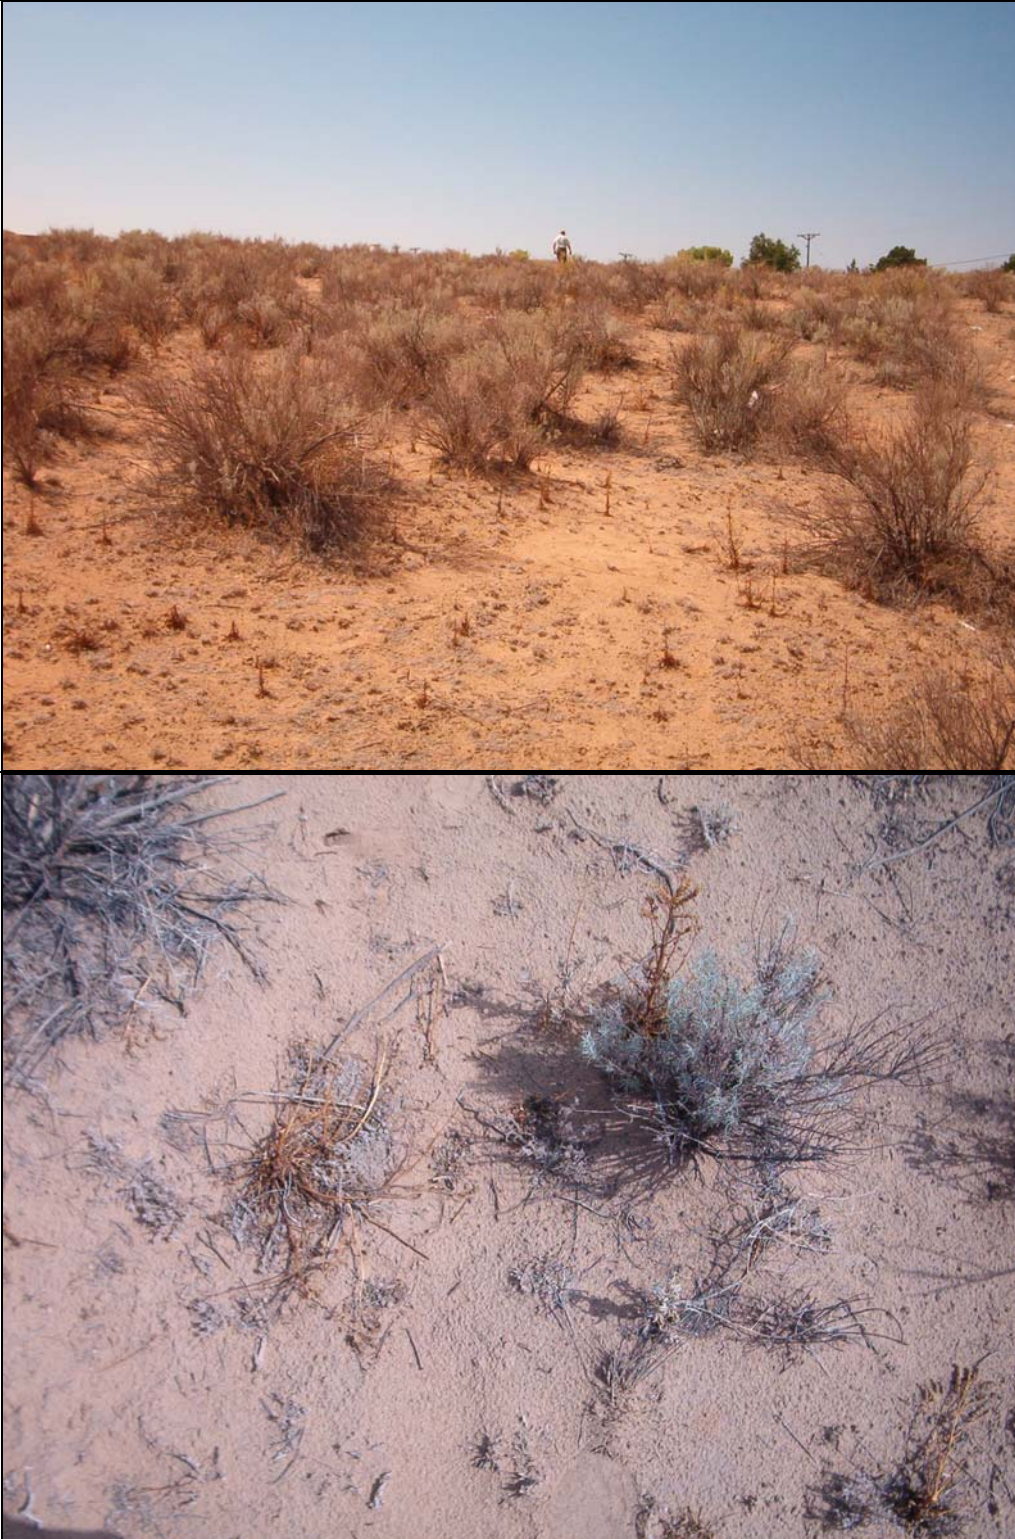
Site Description	C Factor	Picture
<p>Sage Brush, 15% Cover, (150 lbs/ac Biomass), Fall Ht. 0.8 ft, RR = 0.3 in, b- value = 0.05, File Name = Sage</p>	<p>0.134</p>

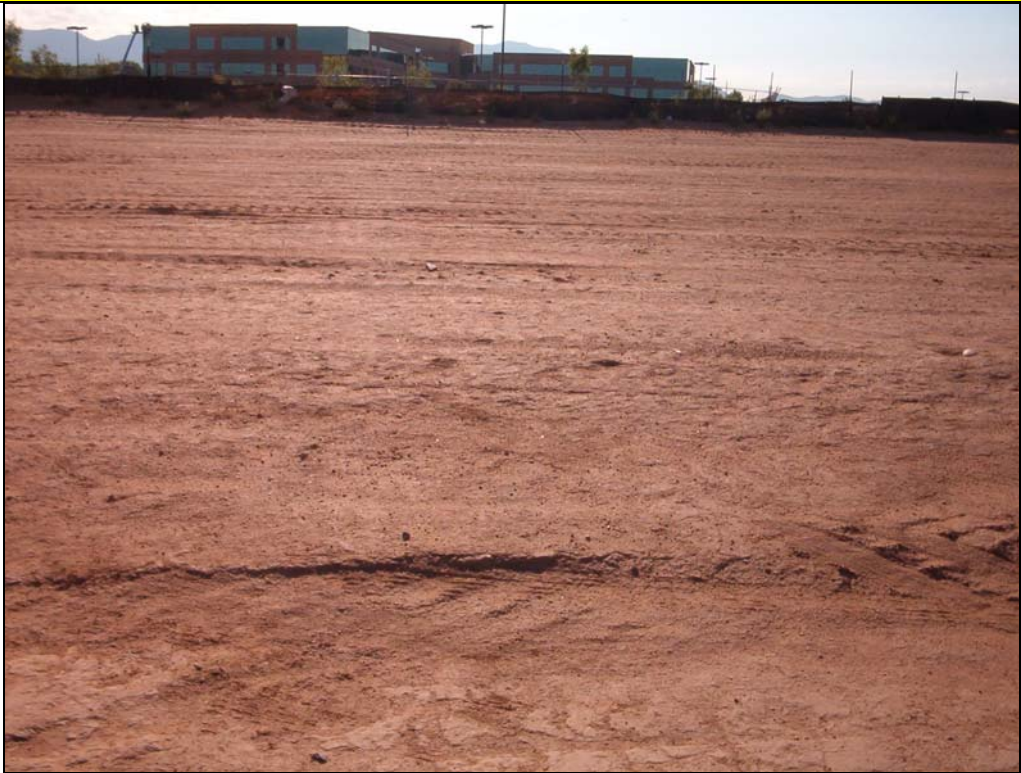
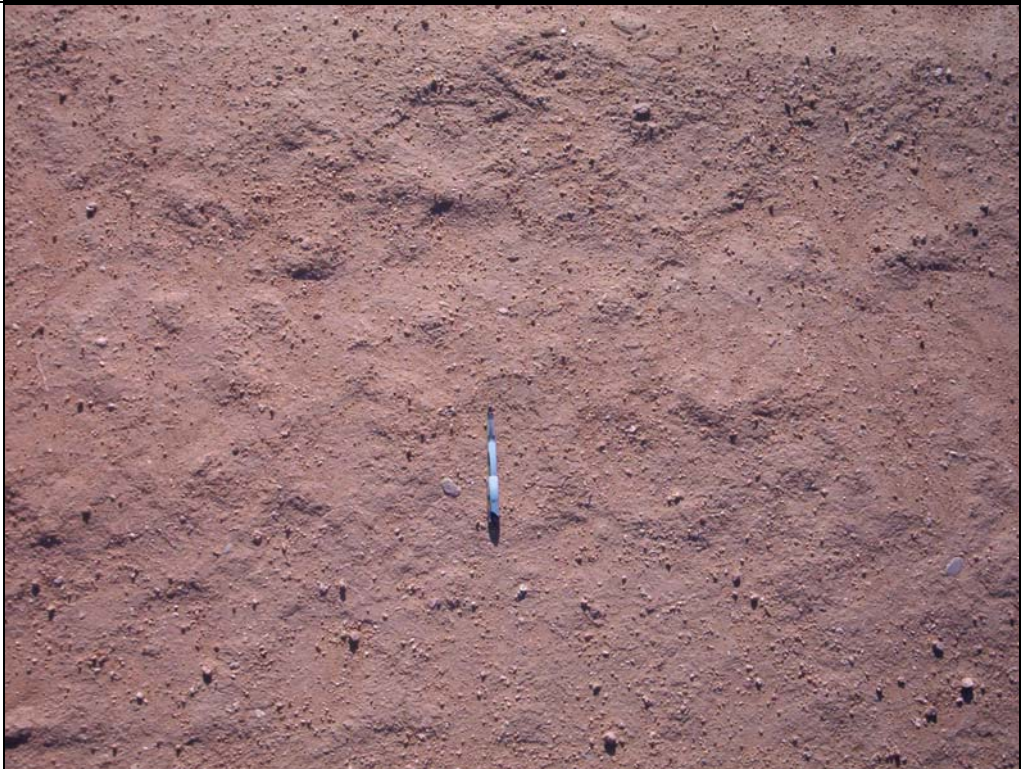
Site Description	C Factor	Picture
Bare Ground, 0% Cover, Disturbed, Cut, Subsoil, No Rock, RR = 0.24, Time variant 1 yr File Name = JurnSand	1.0

A wide-angle photograph showing a large, flat area of reddish-brown, disturbed soil. In the background, there is a long, low building with a blue roof and some trees under a clear sky.

A close-up photograph of the reddish-brown soil surface, showing its granular texture and small clumps. A small, dark object, possibly a pen or stick, is placed vertically in the center of the frame for scale.

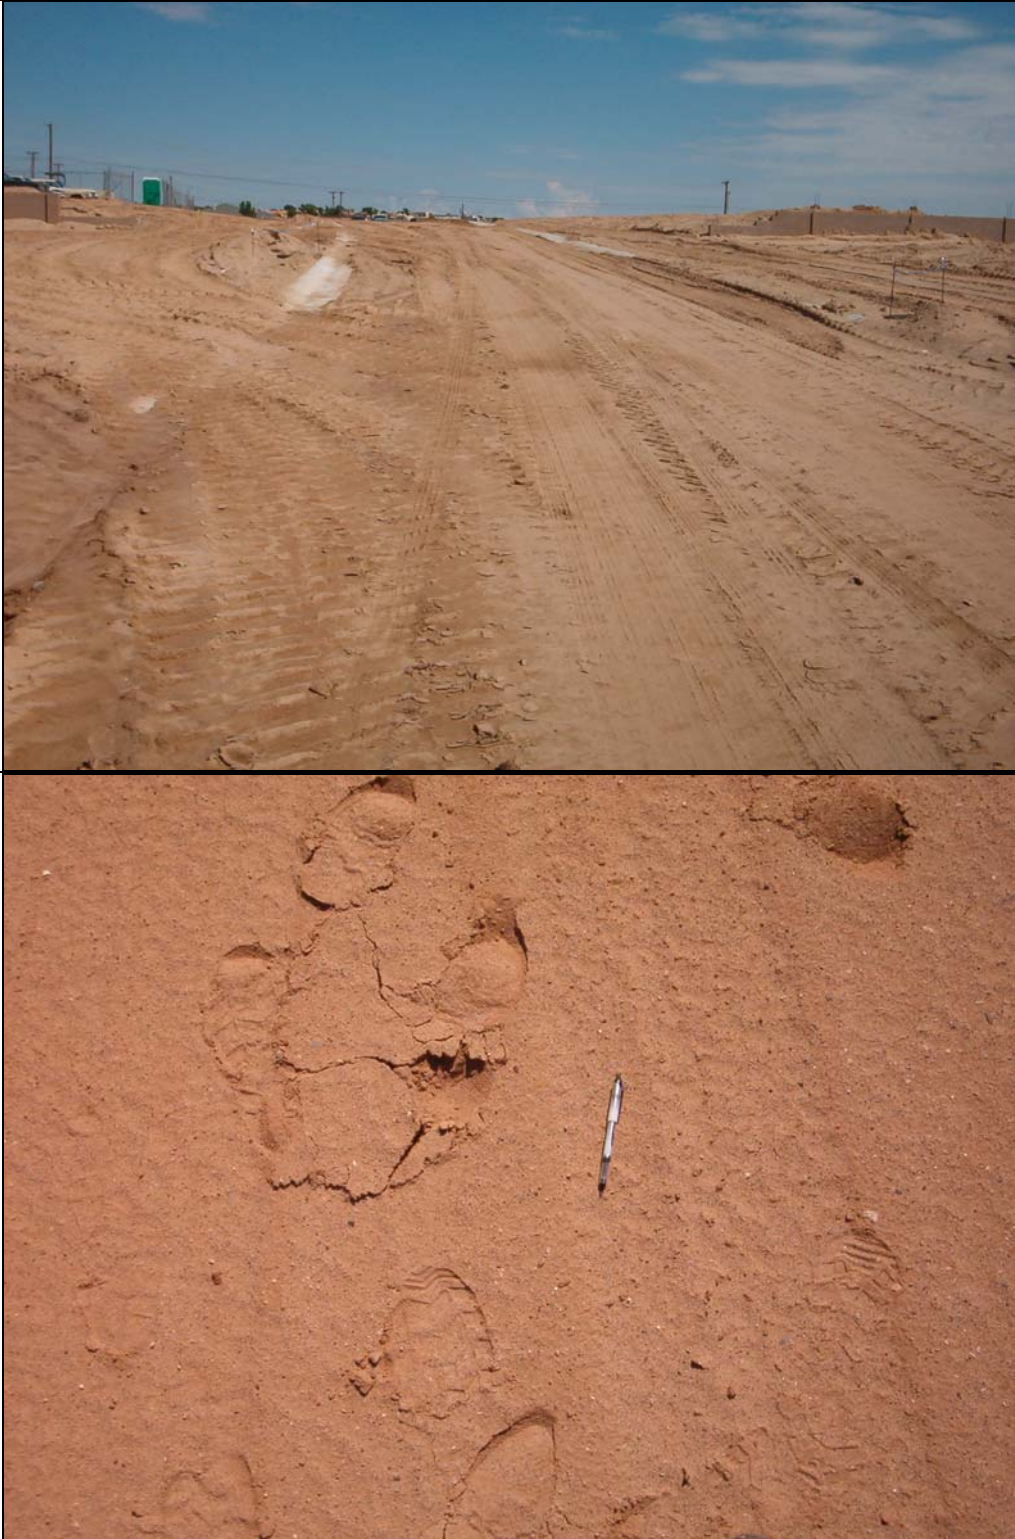
Site Description	C Factor	Picture
Bare Ground, 0% Cover Disturbed, Fill, Subsoil, No Rock, RR = 0.24, Time variant 1 yr File Name = Eagle-S	1.0

The 'Picture' column contains two photographs. The top photograph shows a wide, sandy area, likely a construction site, with visible tire tracks and a blue sky in the background. The bottom photograph is a close-up of the sandy soil, showing a pen placed vertically for scale. The soil is light brown and appears disturbed.

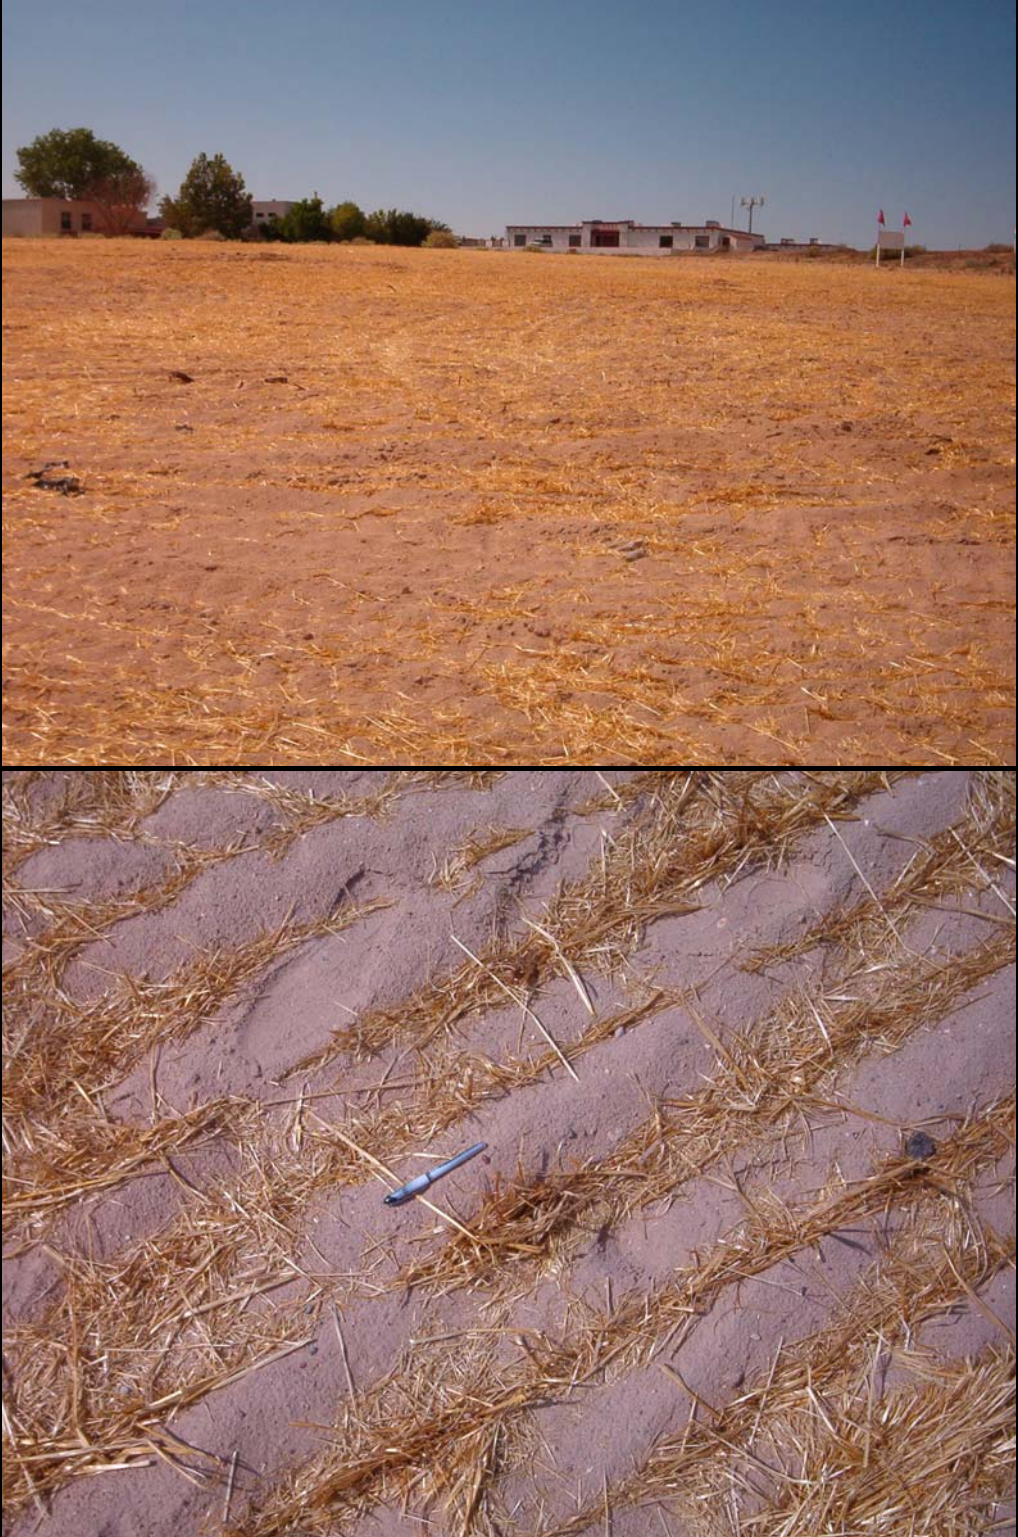
Site Description	C Factor	Picture
<p>Straw Cover, 40% Cover (1075 lbs/ac) Disturbed Fill, Topsoil, No Rock, Feb1 blade & Apr 1 Mulch & Mulch Crimper, File Name = Straw-S</p>	<p>0.291</p>

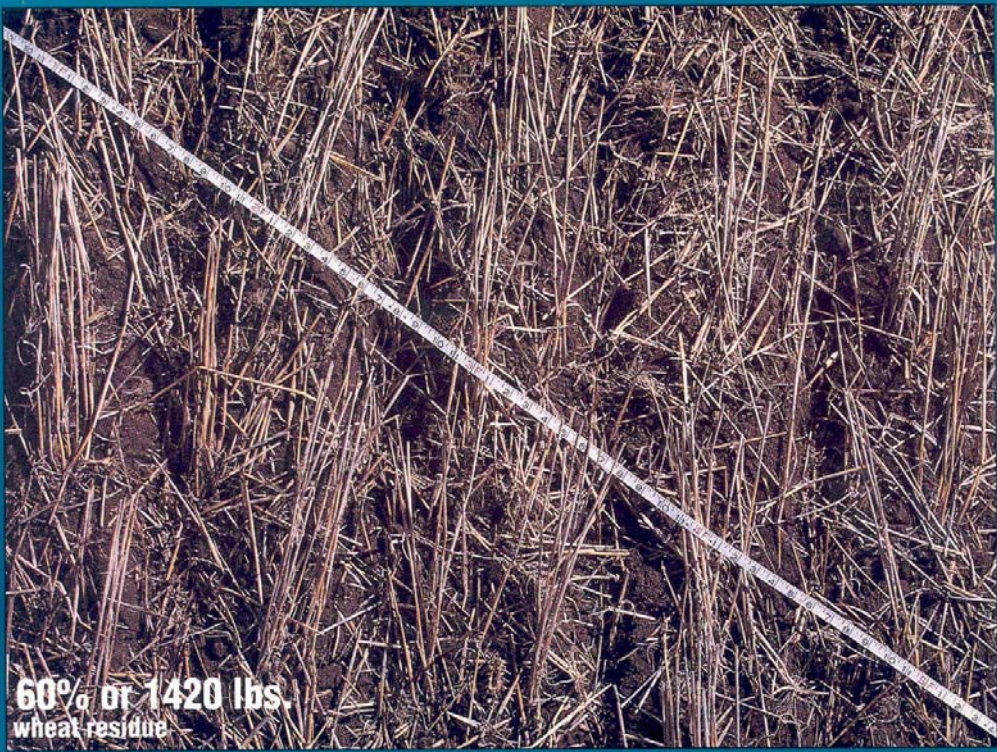
Site Description	C Factor	Picture
<p>Straw Cover, 60% Cover (2050 lbs/ac) Disturbed Fill, Topsoil, No Rock, Feb 1 blade & Apr 1 Mulch & Mulch Crimper, File Name = Straw-S</p>	<p>0.16</p>

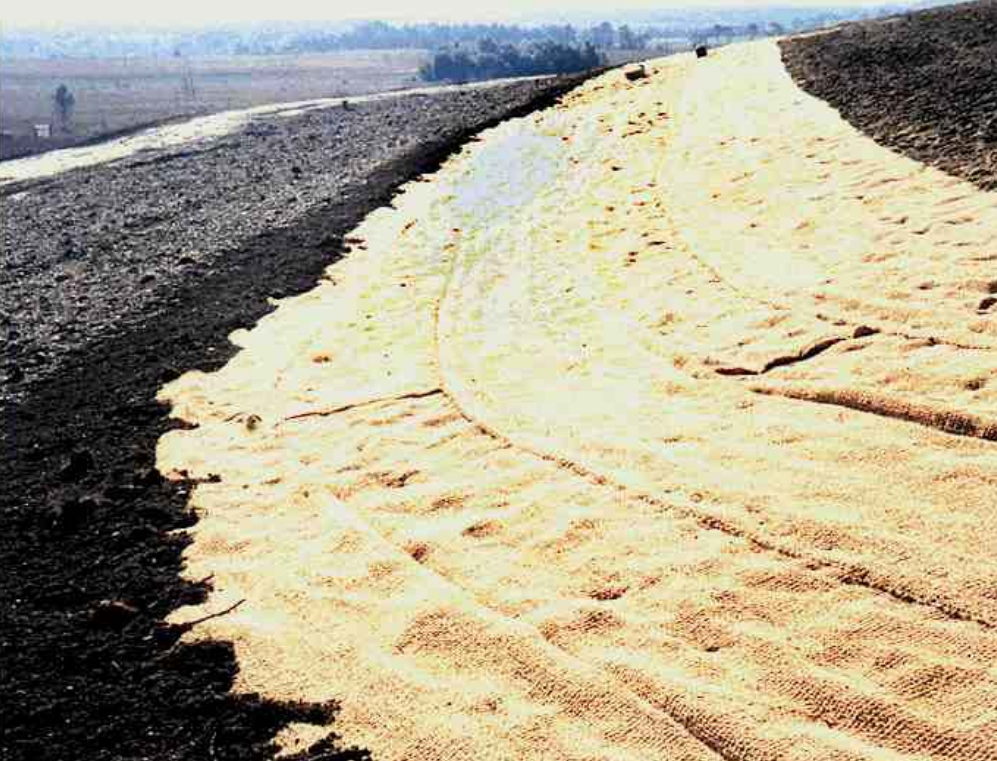
<p>Mat Cover (Bark, Wood chips & Other mulch); Approx. >87% Cover & 3500 lbs/ac material, Disturbed Fill, Topsoil, No Rock Feb 1 Blade & Apr 1 Place Matt File Name = CellMat</p>	<p>w/o Tackifier: 0.086 OR w/ Tackifier 0.084</p>

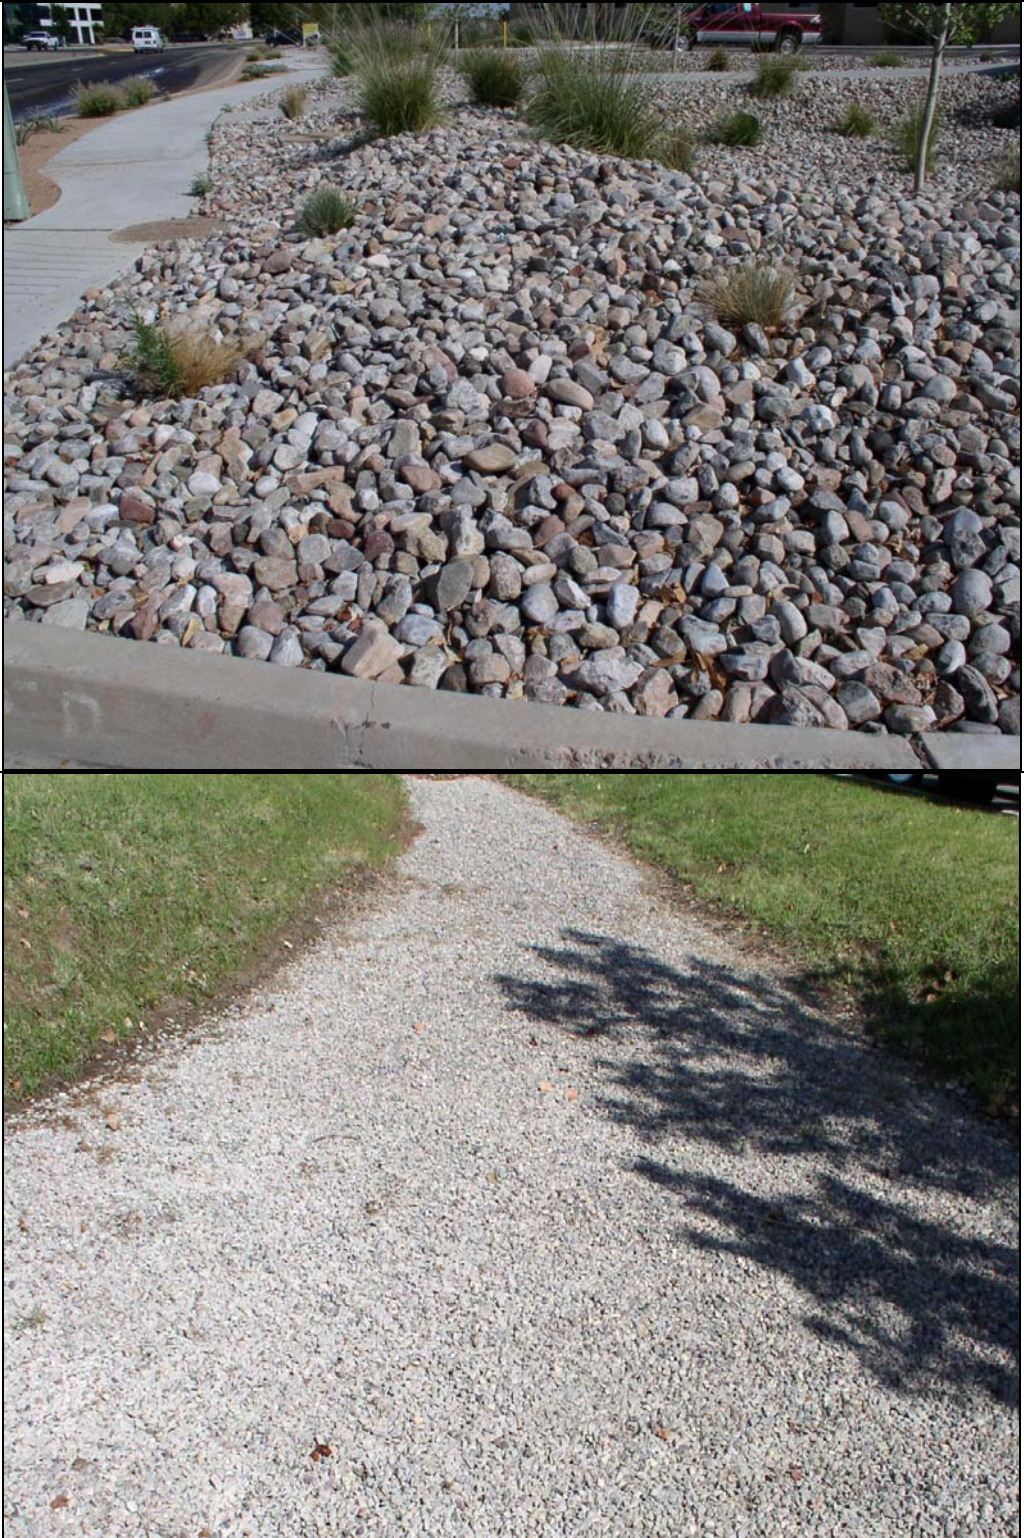
Site Description	C Factor	Picture
<p>Rock Cover, 100% Cover, >23 lbs/ft², Rock Surface Cover, Disturbed Fill, Topsoil, No Rock, Feb1 blade & Apr 1 Rock, File Name = Rock</p> <p>OR</p> <p>Rock Cover, , 50% Cover, 12 lbs/ft², Rock Surface Cover, Disturbed Fill, Topsoil, No Rock, Feb1 blade & Apr 1 Rock, File Name = Rock</p>	<p>0.061 (100% Cover)</p> <p>OR</p> <p>0.204 (50% Cover)</p> <p>Both Pictures Show 100%</p>

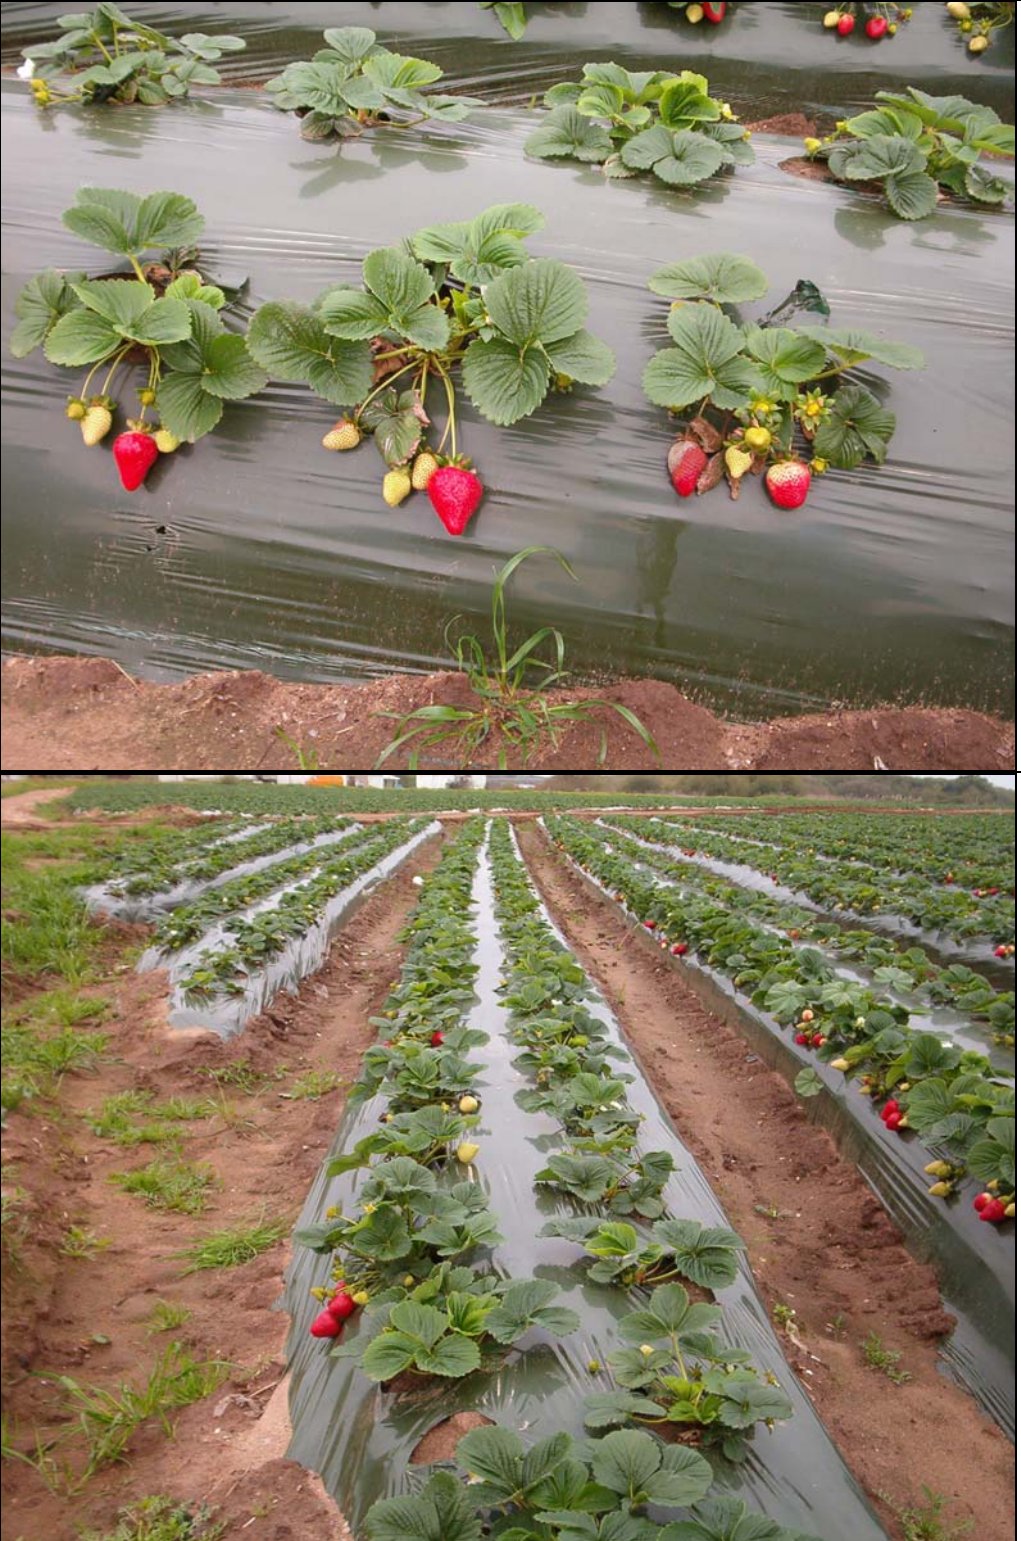
Site Description	C Factor	Picture
<p>Plastic Mulch; 66% Cover, Disturbed Fill, Topsoil, No Rock, Feb1 Blade Apr 1 Plastic Mulch, File Name = Plastic OR Plastic Mulch; 100% Cover, Disturbed Fill, Topsoil, No Rock, Feb1 Blade Apr 1 Plastic Mulch File Name = Plastic</p>	<p>66% Cover (Pictured) 0.136 OR 100% Cover (Not Pictured) 0.061</p>

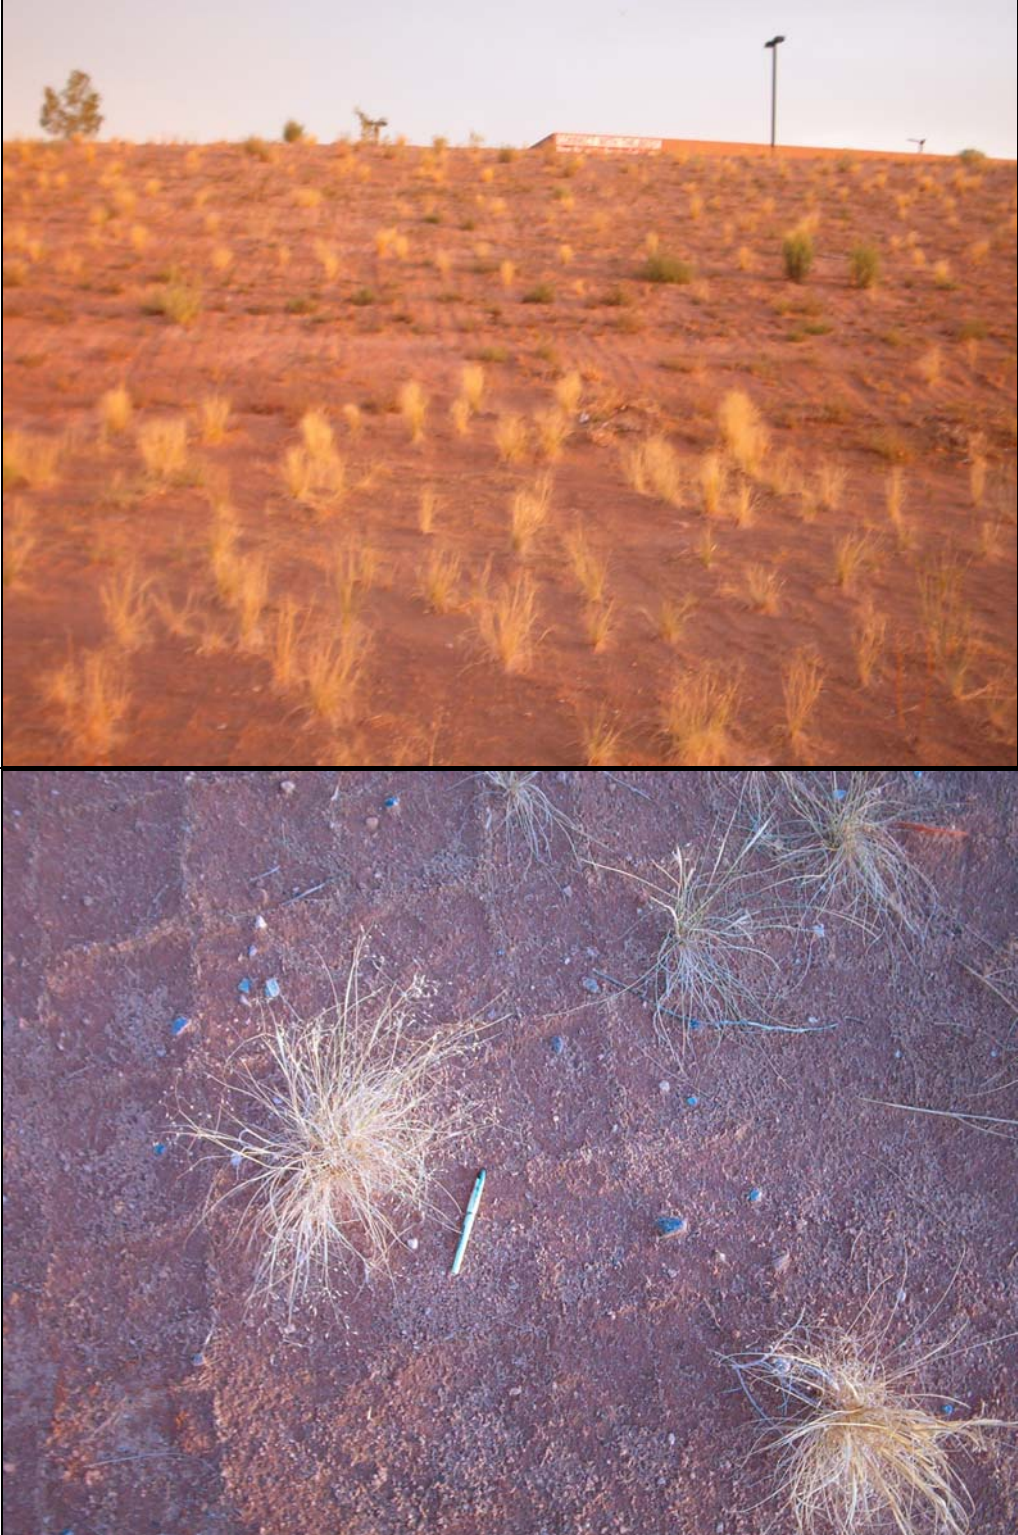
Site Description	C Factor	Picture
<p>Mulch-revegetation 2 yr; 10% Cover, Disturbed Fill, Subsoil, No Rock, (1yr) Feb1 Blade Apr 1 Straw Mulch, Apr 15 Remove straw (wind), Aug 1 Volunteer growth, (2 yr) Aug 1, Ricegrass Begin growth File Name = Sprint</p>	<p>0.17</p>

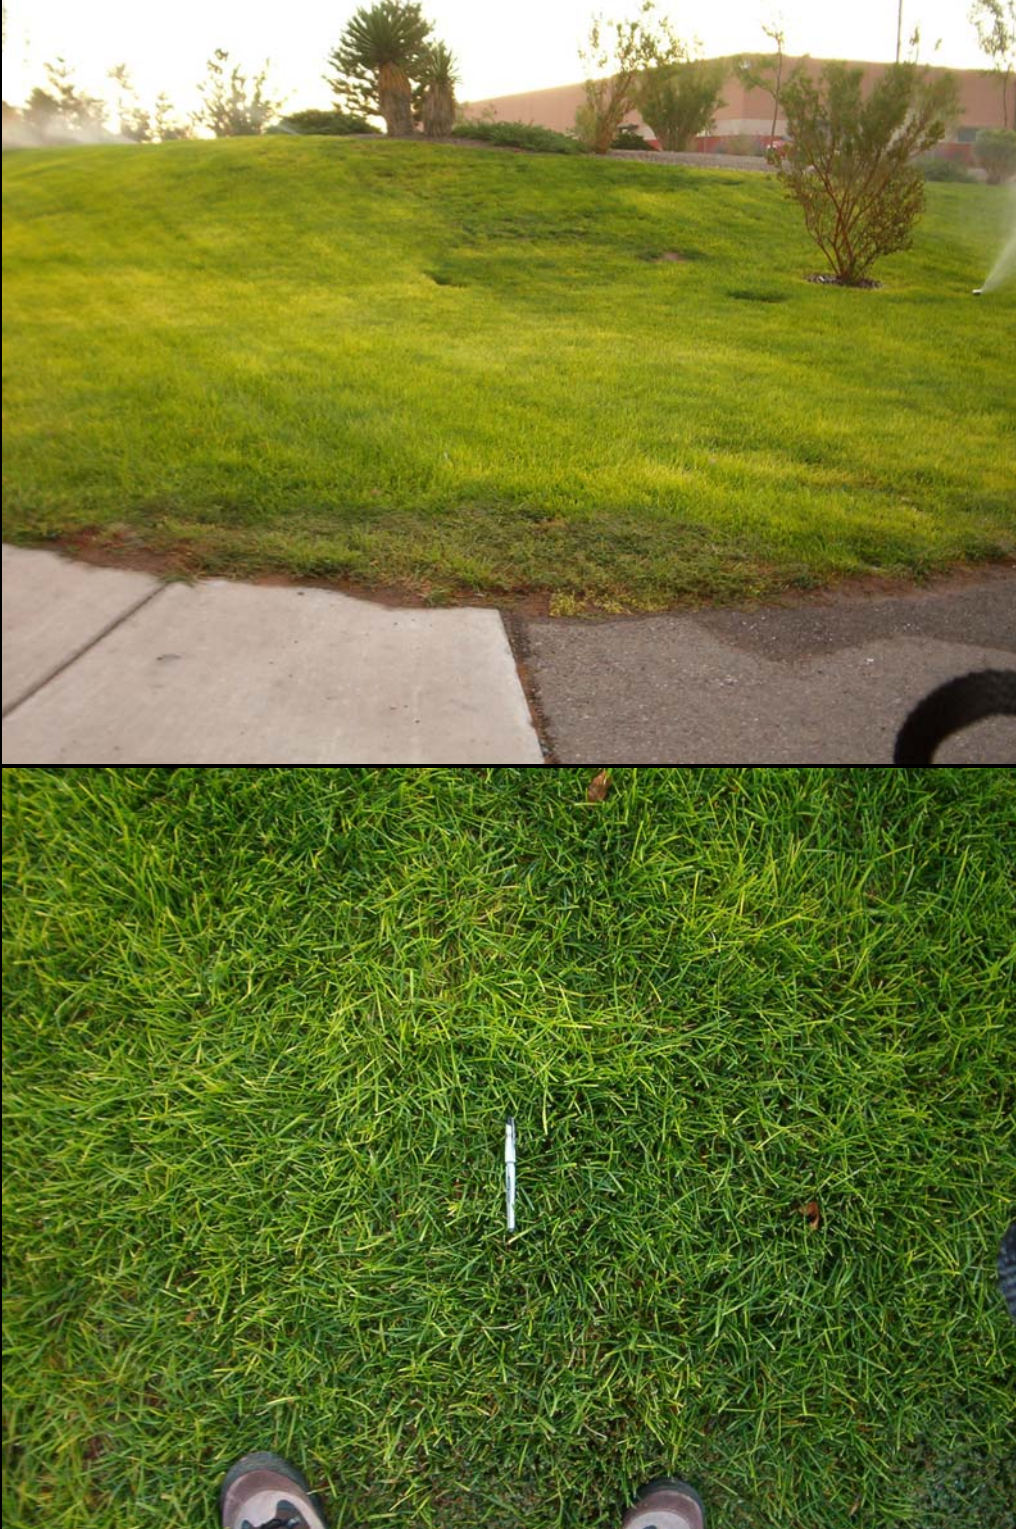
Site Description	C Factor	Picture
Sod Lawn; 100% Cover, Disturbed Fill, Topsoil, No Rock, Feb1 Blade Aug 1 Lay Sod, File Name = Lawn	0.055
